Results summary

Jeff Matthews

Hollowcore Unit Support Detail

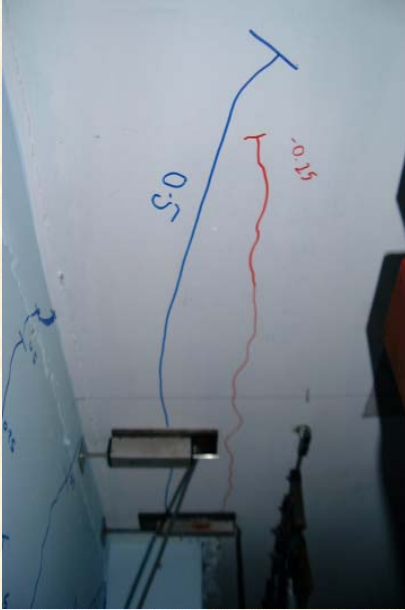
+/-0.25% drift loading cycle

- **First cracks appear in the beams**
- **Crack forms in the bottom of 1st h/c unit**

First crack appear in the beam plastic hinge zone
Hollowcore crack propagates from the corner of the columns where the unit had been cut to fit against the column and perimeter beam

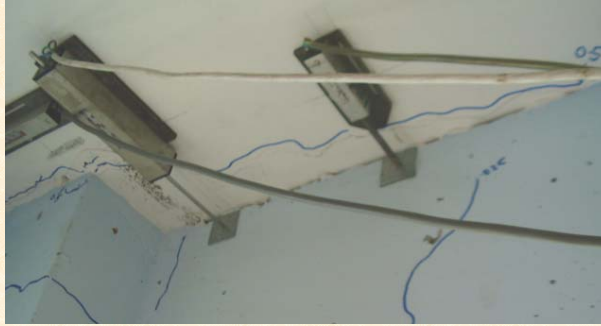
+/-0.5% drift loading cycle ($\mu=1$)

- **Continuity crack forms at end of h/c units**
- **West beam h/c unit starts to crack affecting its seating**

The continuity crack is the crack that opens directly above the edge of the hollowcore unit as the beam rotates relative to the floor
Prying action starts to crack the end of the 1st hollowcore unit on the west beam. (see slide 21 for detail showing prying action)

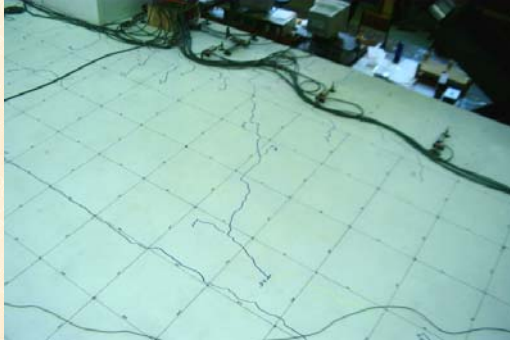
+/-0.5% drift loading cycle ($\mu=1$)

- **Cracks form on the floor around the central column**
- **Torsion crack form in edge beams**

Shear lag cracks start to appear around the central column

Torsion cracks appear in the edge beams as the starter bars lapped into the floor provide restraint. This only occurs when the starters are in tension (I.e. when a negative moment is applied)

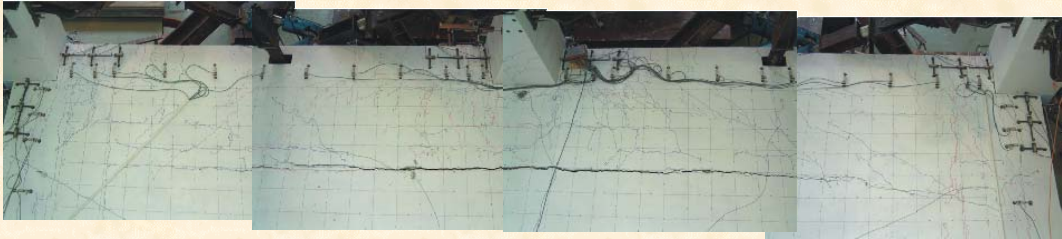
1.9% drift ($\mu=3$)

- Longitudinal “unzipping” of the diaphragm over $\frac{1}{2}$ specimen length
- Majority of mesh fractures

The hairline crack between the 1st and 2nd hollowcore unit has now opened into a 10-20mm wide crack. In doing so all the mesh that passes across that crack has fractured. The diaphragm inertia forces will no longer be able to be transferred over this crack

Note: This occurred at a displacement ductility of 3

If the crack occurred over several floors this could lead to the buckling of a exterior column.

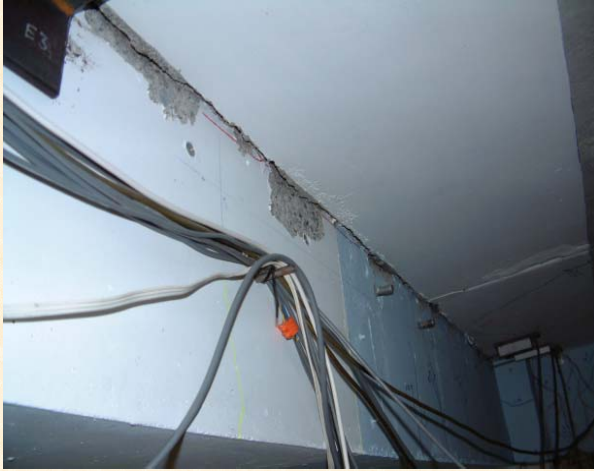
2.5%>-2.0% drift loading cycle ($\mu=4$)

- **Relatively large zones of topping delamination around corner nodes**
- **Entire edge of h/c units damaged**
- **1st h/c unit drops by 5mm**

Delamination propagates along the beams. This is caused by the yielded starter bars popping the topping when the load reverses. The entire seat on both beams is now damaged. Three forms of damage have been noted: H/C units have been pulled off their support (was only observed in a couple of locations); the beam cover concrete has spalled; or the edge of the h/c unit has been broken off (a majority of the seat damage occurred by this mode).

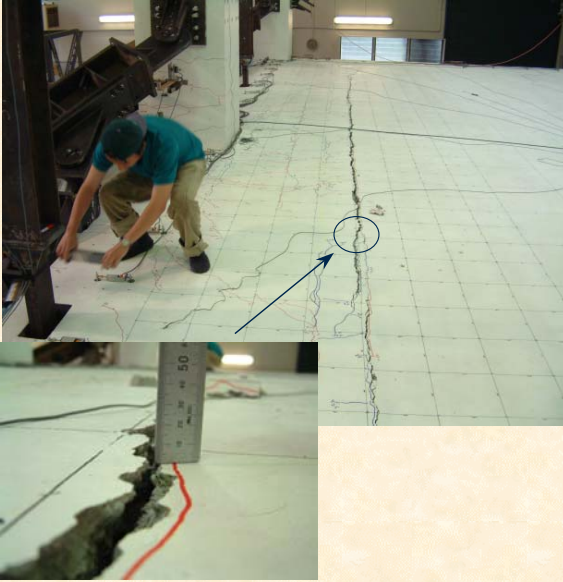
2.5% > -2.0% drift loading cycle ($\mu=4$)

- **20mm offset of central column in orthogonal direction to loading**
- **15-20mm crack in floor, 10mm vertical offset**

At the completion of this cycle the central column had displaced laterally 20mm in the direction orthogonal to the direction of loading.

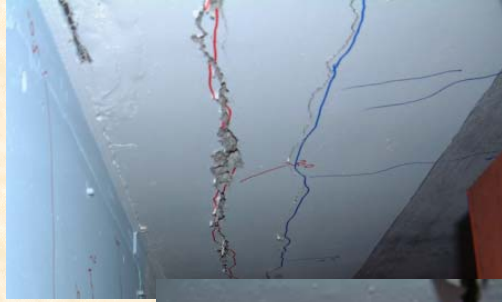
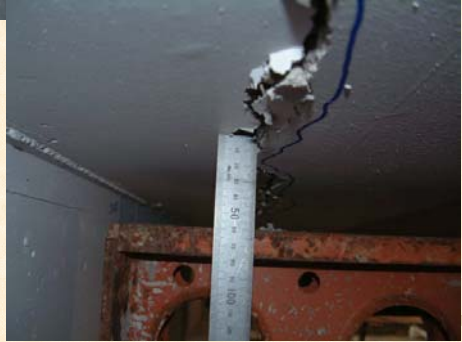
In-plane conclusion

- **Some h/c units have dropped by 10-12mm**
- **1st h/c unit extensively damaged, web split for first 2-3m**

Major web splitting has occurred in the 1st h/c unit at the west end. This splitting propagates for approximately 2-3m into the floor. All the h/c units have started to drop since their seat has been damaged. The damage is due to the displacement demand imposed on the system.

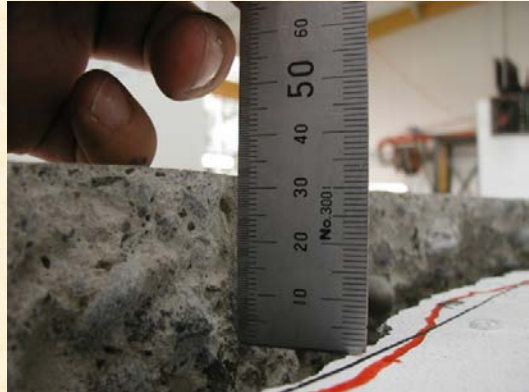
Loading cycles up to 2.5% drift

- **Positive direction of loading, crack in soffit of 1st h/c unit opens**
- **Negative direction, 1st h/c unit is lifted. H/C units connection to edge beam is damaged**

During the loading cycles the 1st h/c unit is rotated, up and down, as there is not enough restraint from the floor due to the fracturing of the topping mesh. This causes the unit to start to degrade. The expected performance was for the beam to rotate relative to the floor causing a continuity crack to form between the beam and the floor, the same as was observed during the in-plane loading. This did not occur

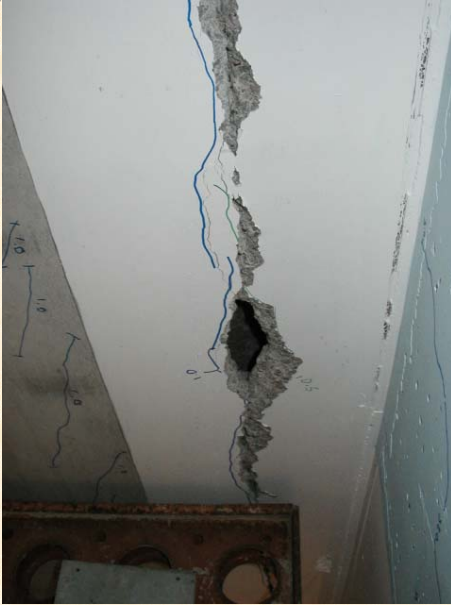
2.0% > -2.5% drift loading cycle ($\mu=4$)

- **More mesh fractures during negative cycles**
- **@2.0% parts of h/c unit fell out**

1st h/c unit has degraded more. The first part of the h/c unit drops out. The longitudinal unzipping on the floor has now propagated to the ends of the specimen. This has caused the remainder of the topping mesh to fracture. This crack propagation has led to the damage of the concrete cover on the east beam

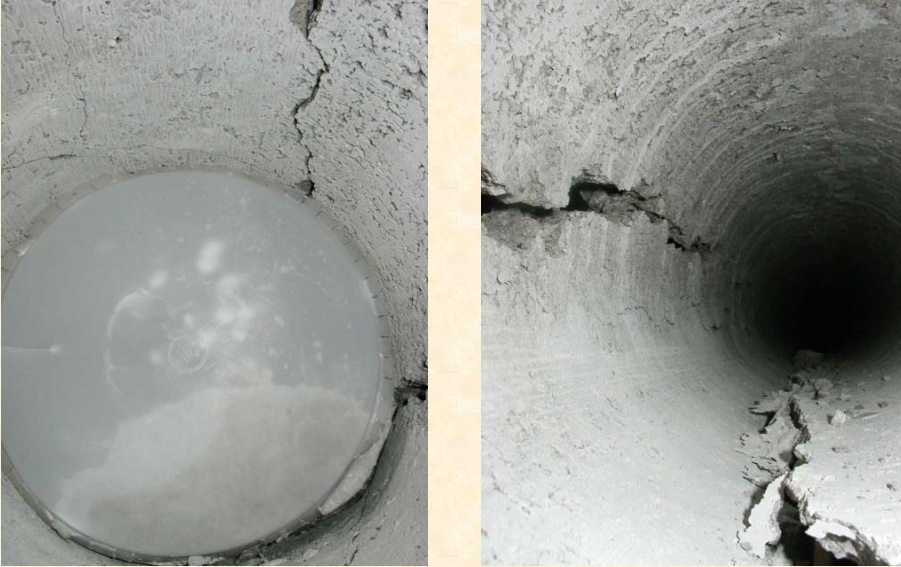
Hollowcore damage (internal)

Left: The h/c unit is starting to drop away from the dam since its seating has been lost

Right: Large cracks in the h/c's web and soffit. The web crack width is approx 25mm.

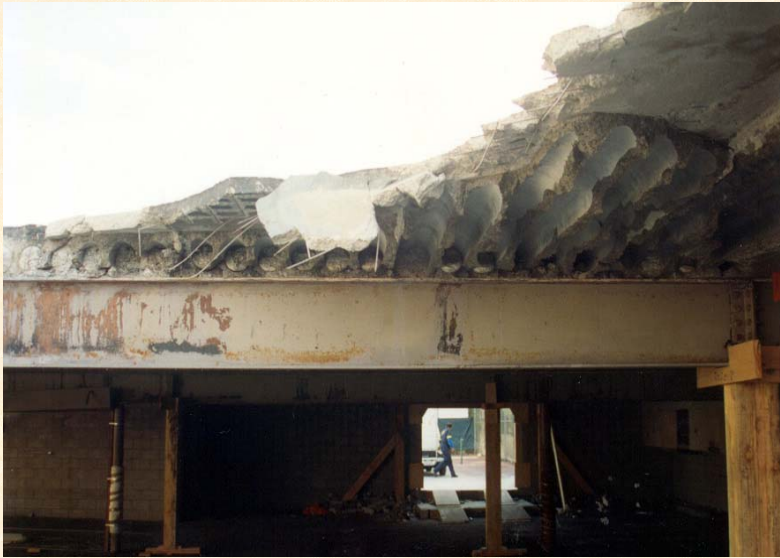
Northridge 1994

When the floor drops the image will look similar to this. Zones of web splitting. Note: the ends of some of the h/c units are still attached to the beam even though the unit has dropped.

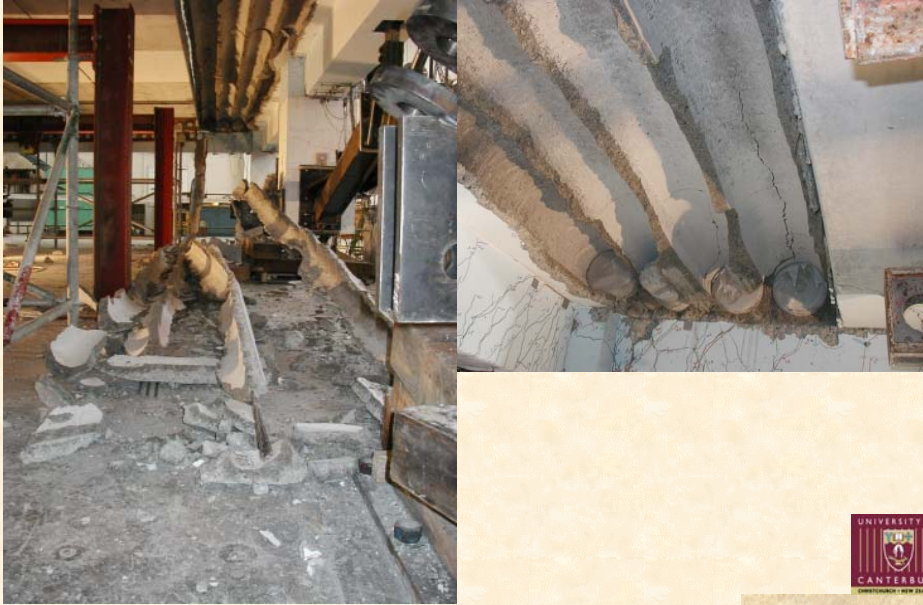
University of Canterbury 2002

Observed behaviour of the 1st h/c unit. The entire bottom half of the first unit dropped once the west end let go. This occurred at a interstorey drift of 2.5%

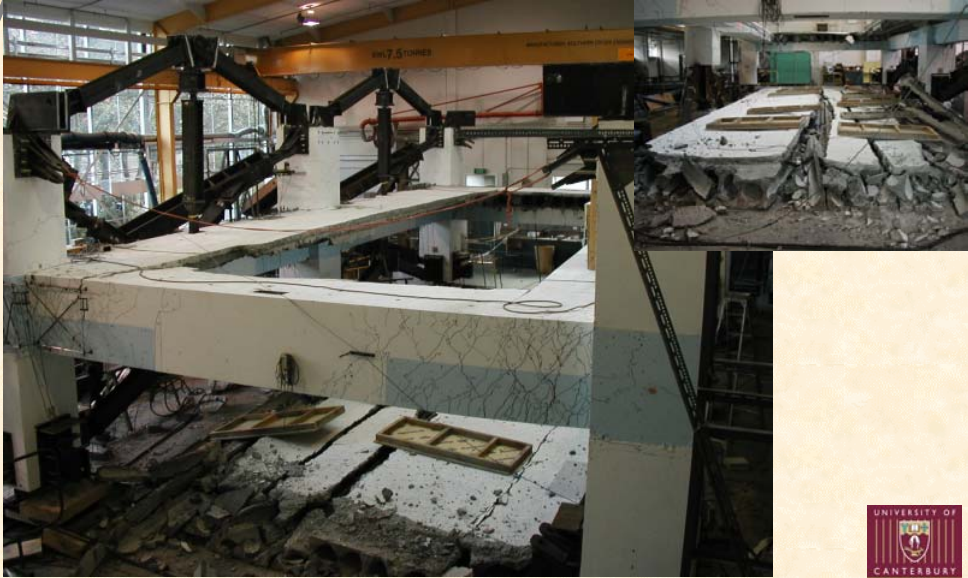
University of Canterbury 2002

The floor was load tested at 2.5% drift. The load applied to the floor represented a 1.0kPa live load and 0.75kPa superimposed dead load. The three units dropped out in one piece leaving the starter bars and its surrounding topping concrete attached.

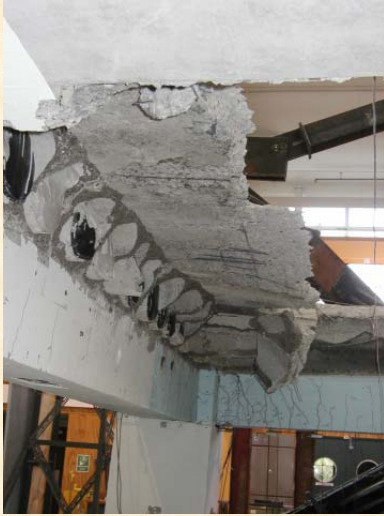
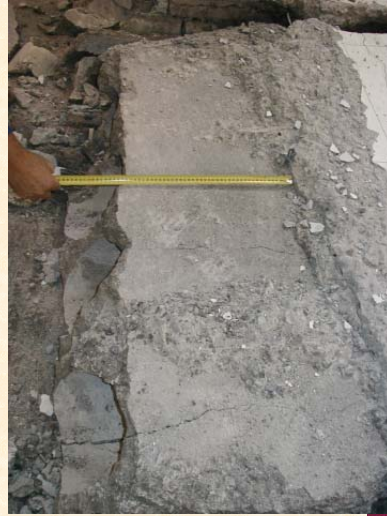
University of Canterbury 2002

Close ups showing the remaining starter bars attached to the beam and the area where the topping has delaminated from the hollowcore units.

Note: In the left hand image a portion of the h/c unit is still attached to the beam (as was seen in the Northridge photos).

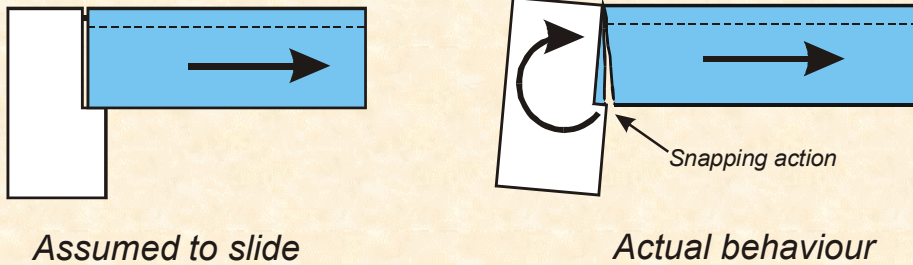
Hollowcore edge support

Left: Assumed performance. This only occurred in some localised regions along the beam. If this did happen then the beam cover spalled.

Right: Actual behaviour. The rotation of the beam caused the edge of the h/c unit to be broken off. The damage is due to the rotation imposed on the h/c unit rather than whether the structure is performing elastically or not.

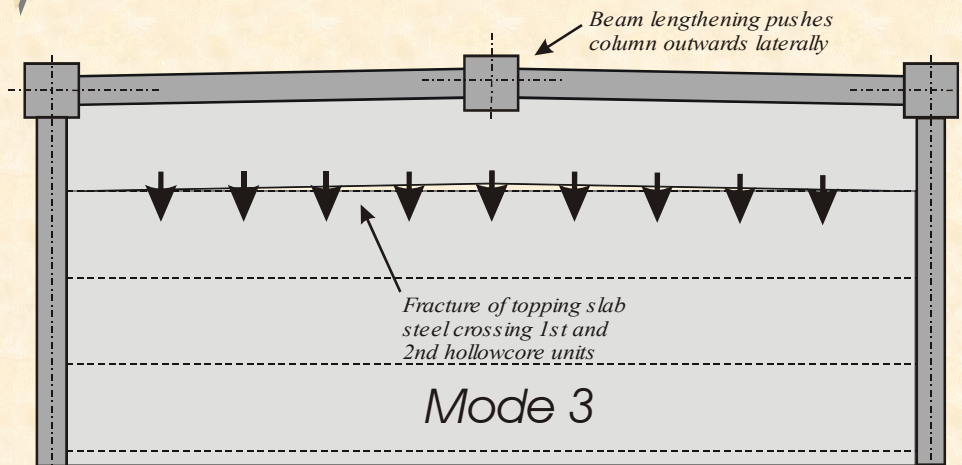
Observed Deformation and failure mode at drift=1.9% ($\mu=3$)

The observed performance is a combination of modes 2 and 3.
