# **Performance of Gypsum Plasterboard Assemblies Exposed to Real Building Fires**

A research report presented as partial fulfilment of the requirements for the degree of  
Master of Engineering in Fire Engineering

Department of Civil Engineering  
University of Canterbury  
Christchurch, New Zealand

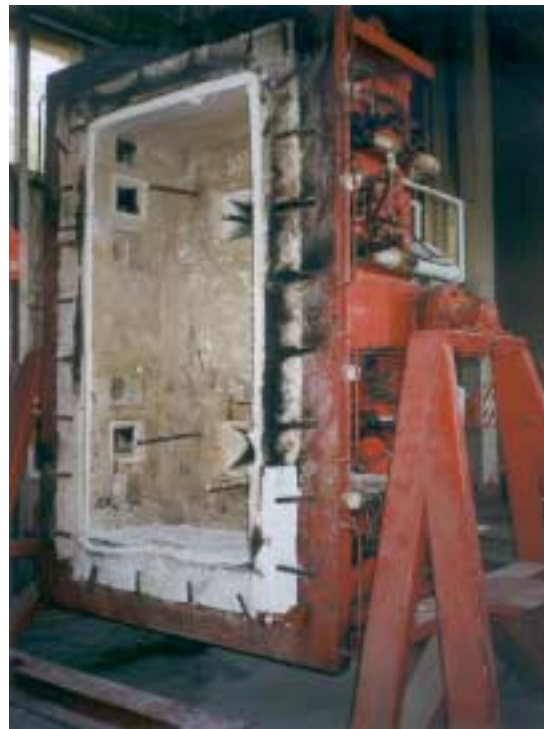
**Figure 5-2: Front view of furnace.**

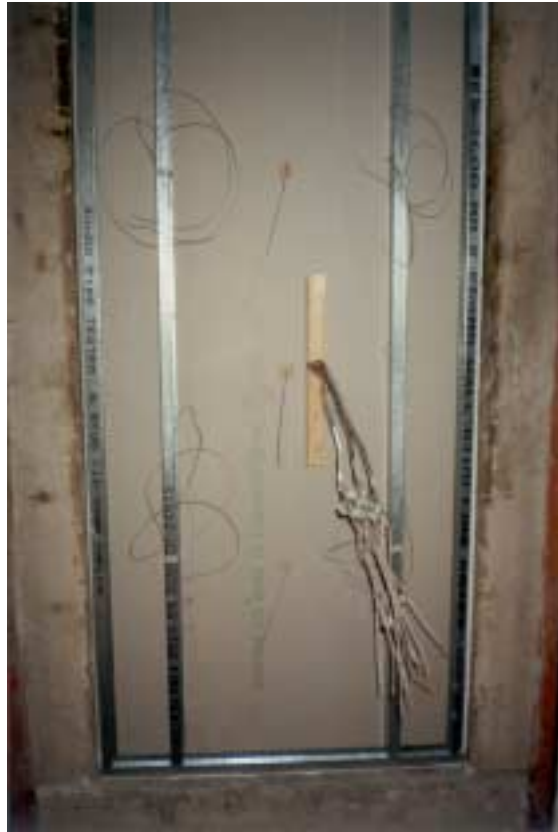
In total, twelve wire thermocouples were welded to the flanges and web of the steel studs, fourteen copper disc thermocouples were employed to measure cavity and lining temperatures as detailed by Figure 5-4, Figure 5-5, and Figure 5-6. Twelve sheathed thermocouples were embedded into a timber dummy stud as detailed by Figure 5-7. Four furnace grade sheathed thermocouples were employed to monitor furnace performance and record temperatures on exposed lining. All thermocouples were calibrated and checked prior to testing. A typical thermocouple set up is shown by Figure 5-8.

**Figure 5-8: Typical thermocouple layout in specimen.**

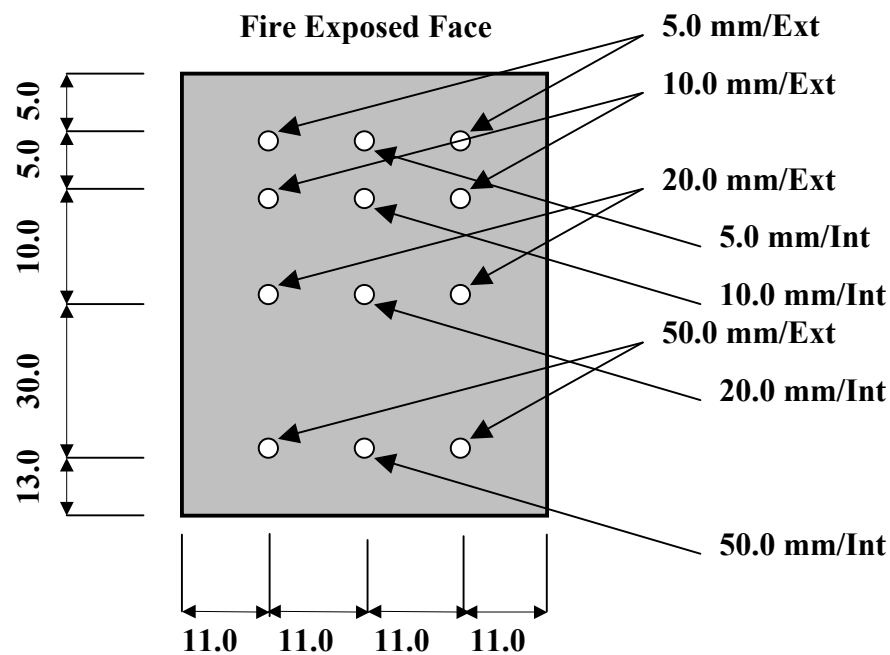
**Figure 5-21: Thermocouple key for plots.**

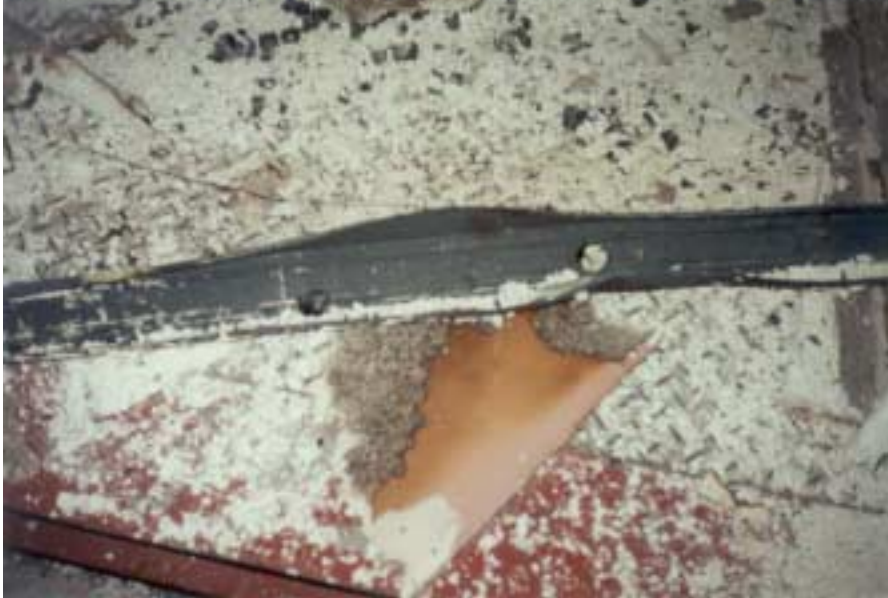
**Figure 7-2: Buckling of steel stud from furnace test FP2881.**

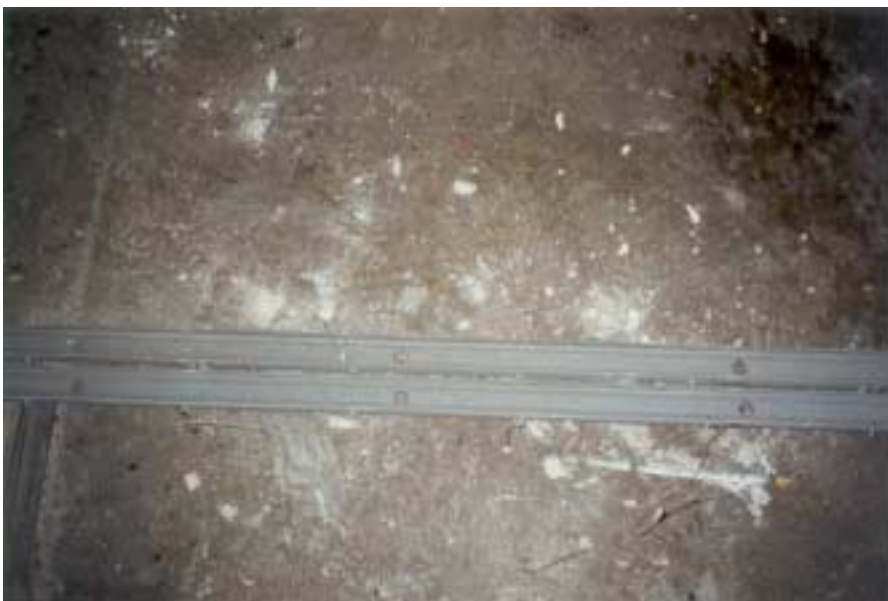
**Figure 7-3: Relatively unaltered studs after furnace test FP2882.**

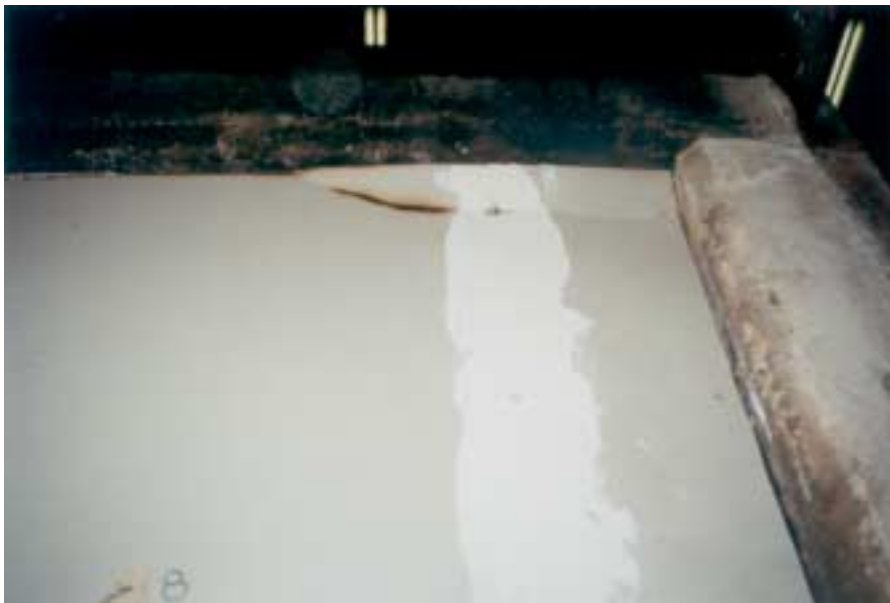
**Figure 7-4: "Push-out" of the unexposed gypsum lining.**

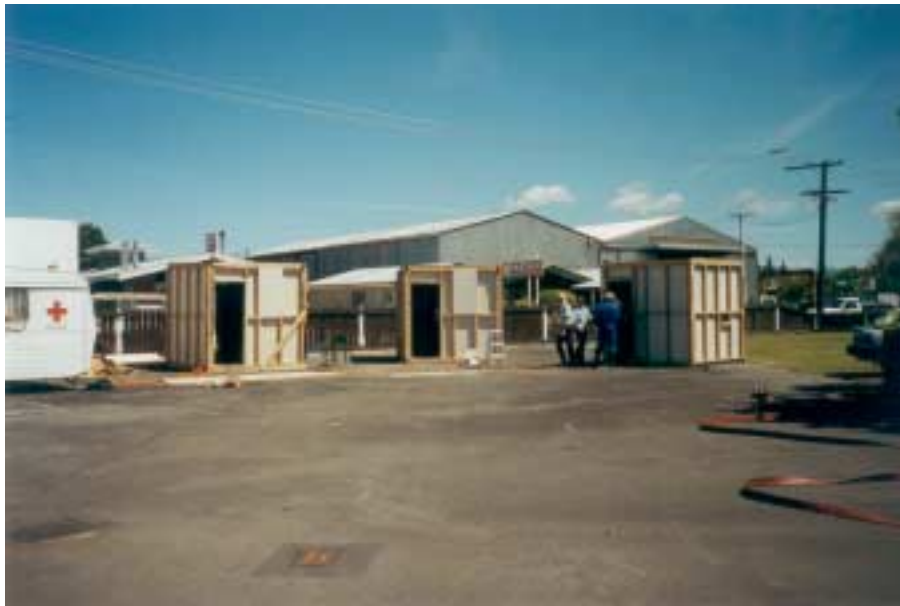
**Figure 8-1: Testing site for compartment tests with the three modules in place.**

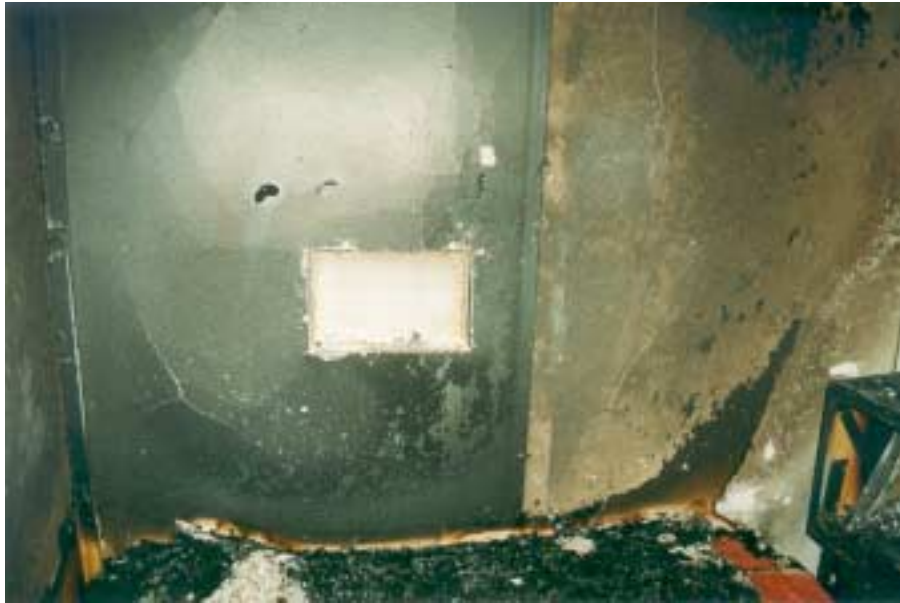
**Figure 8-12: Different burn-off behaviour of paper exhibited by standard and fire rated plasterboard. (Note that GIB<sup>®</sup> Fyreline is on the right of the picture and standard GIB<sup>®</sup> board is on the left).**
