Results summary

Jeff Matthews

Hollowcore Unit Support Detail

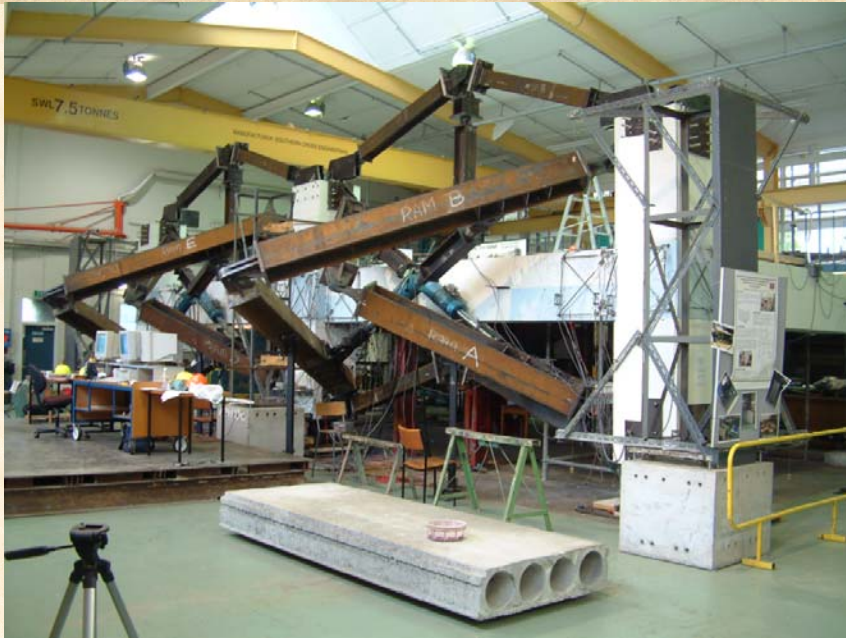
IN-PLANE LOADING

The loading is applied in a direction parallel to the hollowcore floor units

The scissor load frames (i.e. Rams A & B plus D & E) apply a shear force to the top and bottom of the columns

The arrow frame ensures that the columns remain parallel at all times

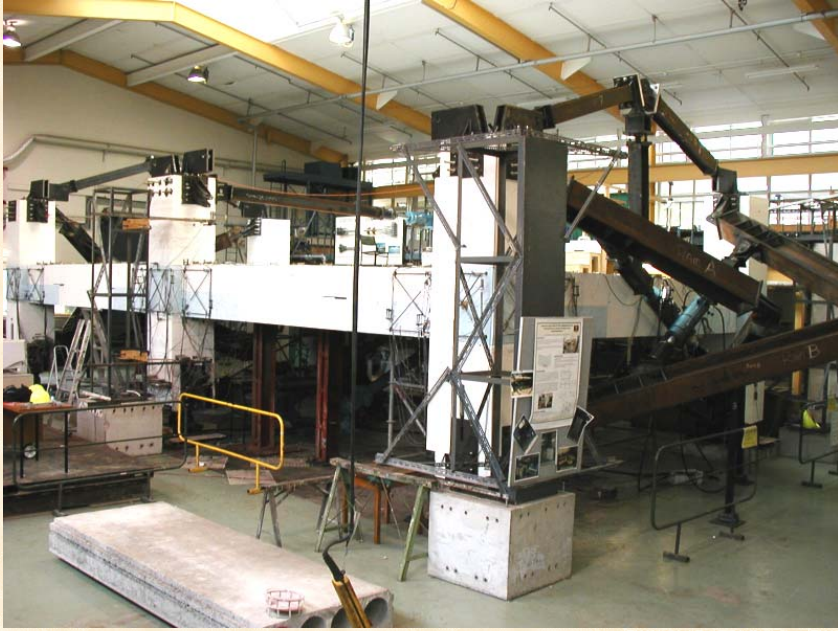
OUT-OF-PLANE LOADING

Load frames have been changed to load the specimen in a direction orthogonal to the h/c units

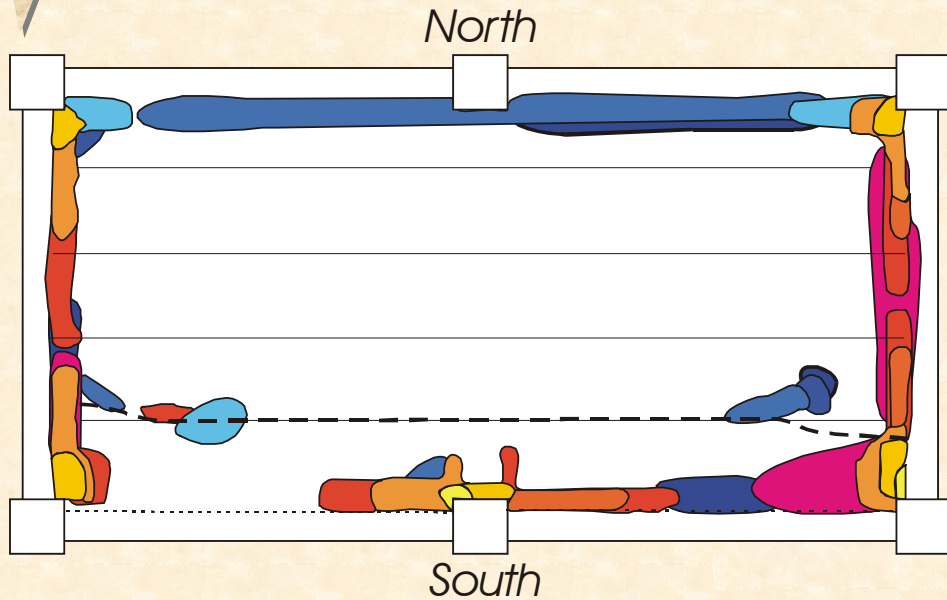
Delamination map

Yellow-Red scale is used for in-plane loading [East-West loading]
Blue scale has been used for the out of plane loading [North-South loading]

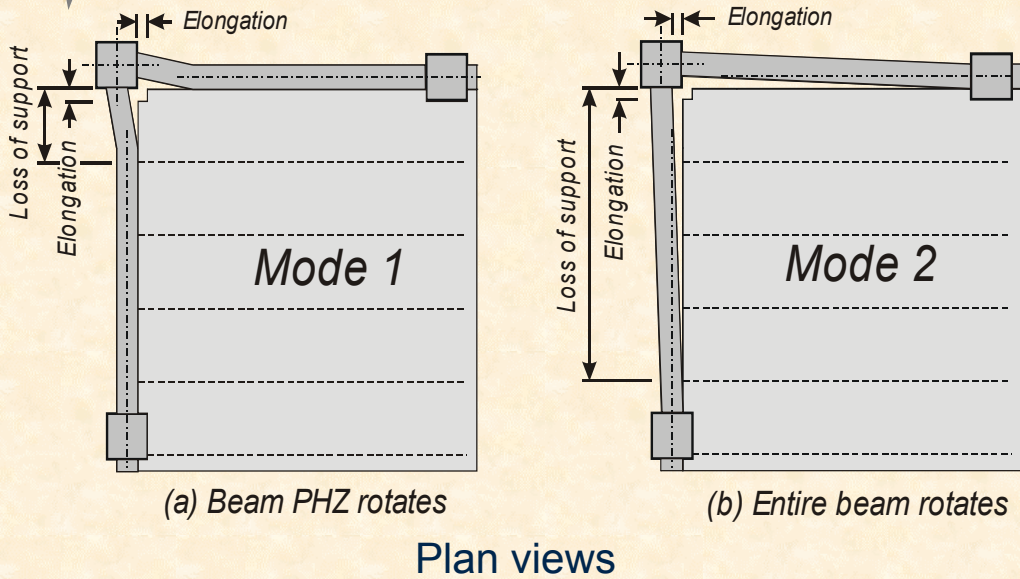
Previous Speculated Deformation modes

Observed Deformation and failure mode at drift=1.9% ($\mu=3$)

The observed performance is a combination of modes 2 and 3.
